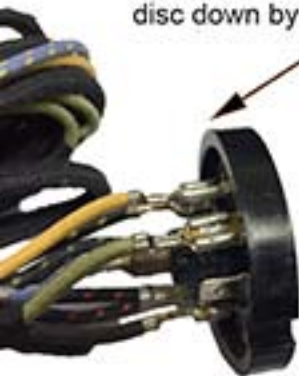
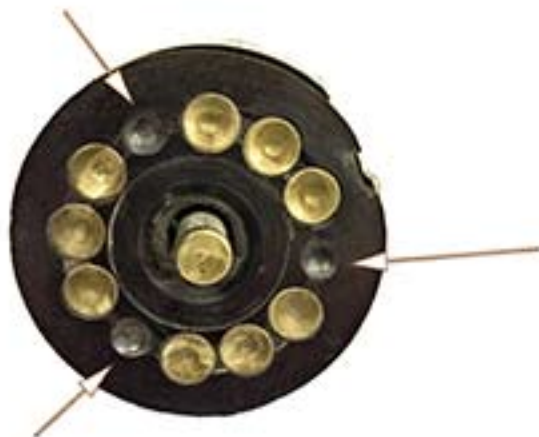
There are two problems with the wire disc. First the disc should be .315 (5/16") thick, but was made .350 or .035 too thick. When installed, the disc will be so **tight** against the brass ring it will not allow you to turn the handle in the steering wheel. **To correct**, file the back of the disc down by .035 (1/32") or grind the top of the lower cup down .035.

The second problem are the three Black OFF detents. They are .017 deeper resulting to make it harder to move out of the detent. Take a knife and scrap the edge of the hole to taper edge.
